# Manhole Inspection Summary

Manhole # S09II2010MH

**Location** Address: **6305 GREEN MEADOW PKWY** Cross Street: **EDENVALE RD**

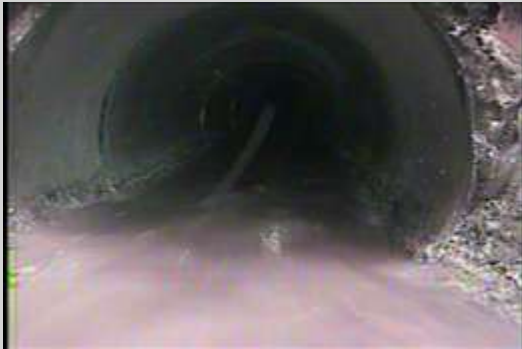
### 15 in. Circular Gravity Sewer Pipe Out @ 12 O'Clock

Rod and Bar (Angled)

Pipe Material: **Clay** ☒ Pipe Lined

Infiltration: **None** Pipe Seal Cond: **Unknown**
